# Construction for Destruction: Downriver Diversion Dam Modifications Required for Matilija Dam Decommissioning

Aric Torreyson<sup>1</sup>, Krey Price<sup>2</sup>, Bob Hall<sup>3</sup>

<sup>1</sup>Senior Project Manager, Tetra Tech, Inc., Los Angeles, USA

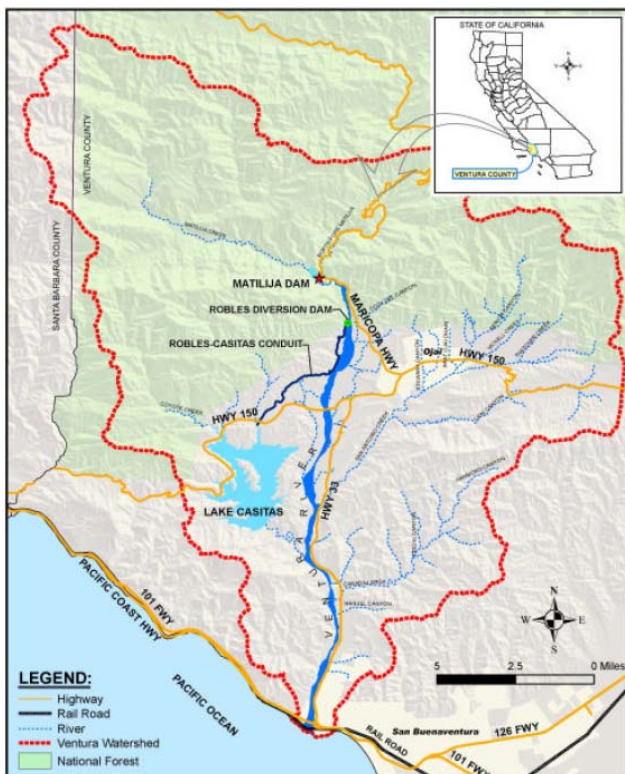
**Figure 1. Ventura River Catchment Overview**

Matilija Creek joins the North Fork Matilija Creek to become the Ventura River approximately 25 kilometres from its mouth at the Pacific Ocean. The Matilija Dam and Robles Diversion Dam sites are located along the upper reaches of the Ventura River in Southern California. The location of the catchment relative to the State of California is shown in Figure 1.

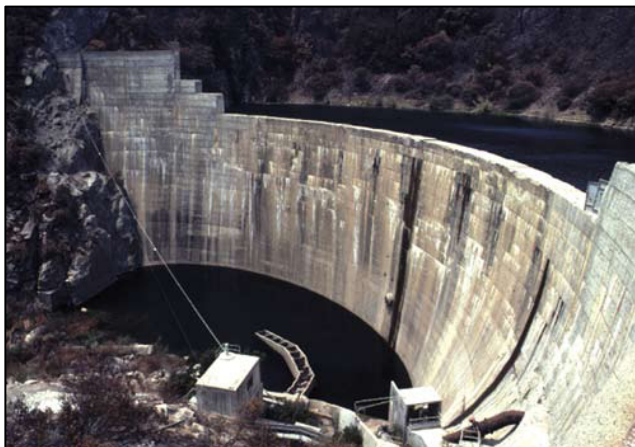
Figure 3. Matilija Dam in 2004

The additional pressures exerted by the sediment load, along with concerns regarding alkali-reactive aggregate, required the dam to be notched several times to reduce its capacity and the accompanying strain from hydrostatic and soil pressures. In its current configuration – accounting for the notching – Matilija Dam stands 51 metres high; the current reservoir capacity, excluding sedimentation losses, is approximately 5 gigalitres. Figures 3 and 4 show the present dam and reservoir.

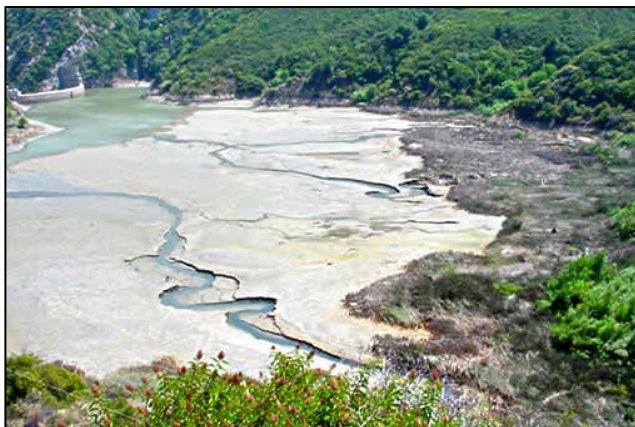
Figure 4. Reservoir Siltation (photo by Paul Jenkins)

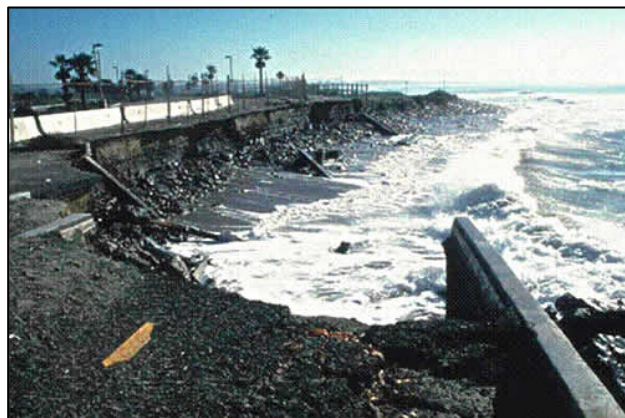
Figure 5. Ventura Beach

Ventura Beach is a popular surfing destination. Replenishment of beach sands transported through littoral drift decreased significantly following construction of the dam, resulting in a net sediment deficit near the Ventura River mouth. The Corps sediment transport modelling efforts (2006) were inconclusive regarding the amount of coastal erosion attributable to the dam. Figure 5 shows erosion at Ventura Beach following a storm.

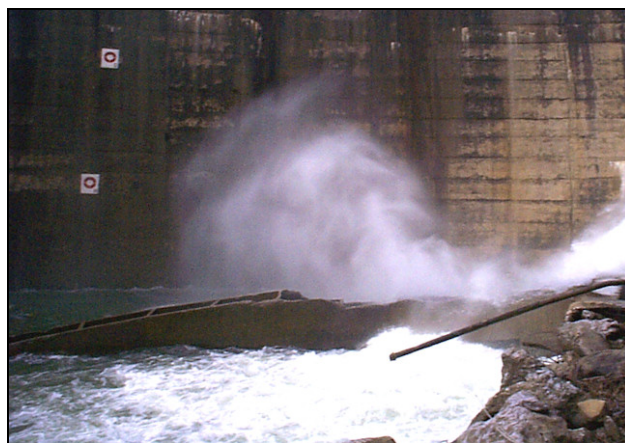
Figure 6. Existing Fish Ladder at Matilija Dam

In 1949, just one year following construction, fish kills related to high temperatures in the stagnant water of the reservoir were recorded. A fish ladder constructed in 1956 proved ineffective, and Matilija Dam remained essentially impassable to migrating fish. The number of steelhead migrating to spawning grounds in the upper Ventura River catchment decreased from an estimated 5,000 in 1940 to several dozen in 2000 (NOAA 2005).

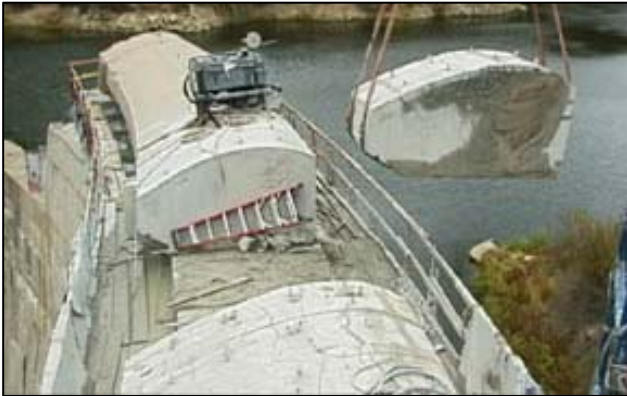
**Figure 7. Concrete removal in 2000**

In light of the sedimentation and fisheries concerns, government studies of removal scenarios were undertaken with mounting public support. As shown in Figure 7, a demonstration section was removed in 2000 to test the

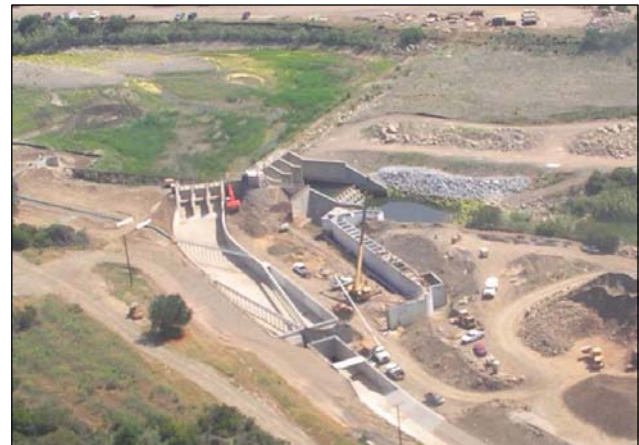
**Figure 9. Robles Fish Ladder under Construction**

Robles Diversion Dam was constructed in 1958 as part of the Ventura River Project. A diversion canal was concurrently constructed from the diversion point to Lake Casitas, which had been formed by the construction of Casitas Dam along Coyote Creek under the Ventura River project. During the wet season, Robles Diversion Dam diverts water from the Ventura River into Lake Casitas in the adjacent subcatchment through a gravity flow system. A conduit system comprising 50 kilometres of pipe conveys flows from Lake Casitas to the population centres downstream. A USD \$9 million fishway was added in 2004. Figure 9 shows an aerial view of the diversion dam with the fishway under construction.

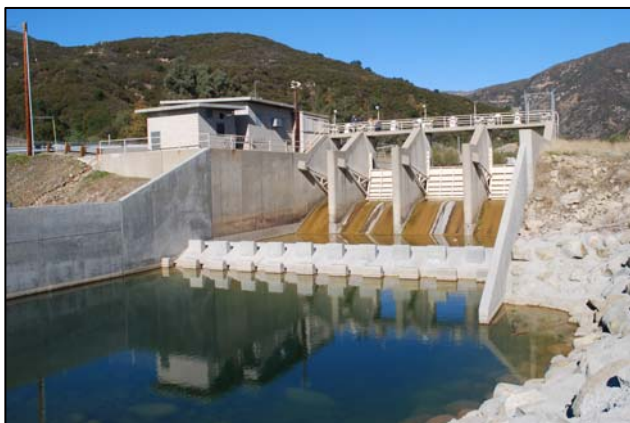
**Figure 10. Robles Diversion Dam in 2008**

The existing drainage area upstream of the diversion is approximately 200 square kilometres, and the 100-year peak discharge is approximately 770 cubic metres per second (cms). The existing diversion dam consists of an 8-metre high by 100-metre wide, in-channel, rock-filled embankment with impervious core and bypass structure. The normal operating depth is 4 metres. The diversion control structure comprises a single-leaf overshot gate and electronically controlled hoist assembly.

The existing spillway capacity is approximately 170 cms, and the existing diversion canal capacity is approximately 15 cms. The bypass and diversion include a gate-controlled bypass structure for the Ventura River (one 3-metre by 3-metre radial gate and three 5-metre by 3-metre radial gates) and a gate-controlled canal diversion

structure with a debris barrier (three 4-metre by 3-metre radial gates).

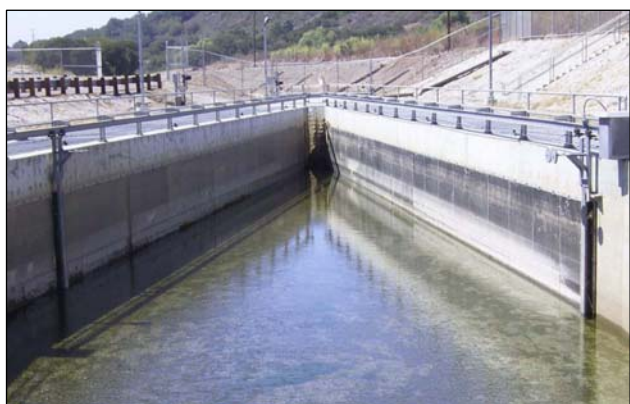
**Figure 11. Fish screen and cleaning brushes**

Because Matilija Dam represents a complete fish passage barrier just upstream of the Robles structure, the benefits of providing fish passage through the diversion dam are limited so long as Matilija Dam remains in place; the original diversion structure was thus constructed without providing for fish passage. Environmental pressures continued to mount, however. At this time, federal officials estimate that only about 100 adult steelhead remain in the Ventura River Catchment. In light of the federal listing of the steelhead trout as endangered, fish passage facilities providing both juvenile and adult passage were constructed in 2004, and environmental flow criteria were implemented to provide passage of adult and juvenile steelhead around the diversion dam. As shown in Figure 11, the existing fish screen applies a chevron-configuration, vertical plate design with travelling brush mechanisms and adjustable velocity distribution baffles.

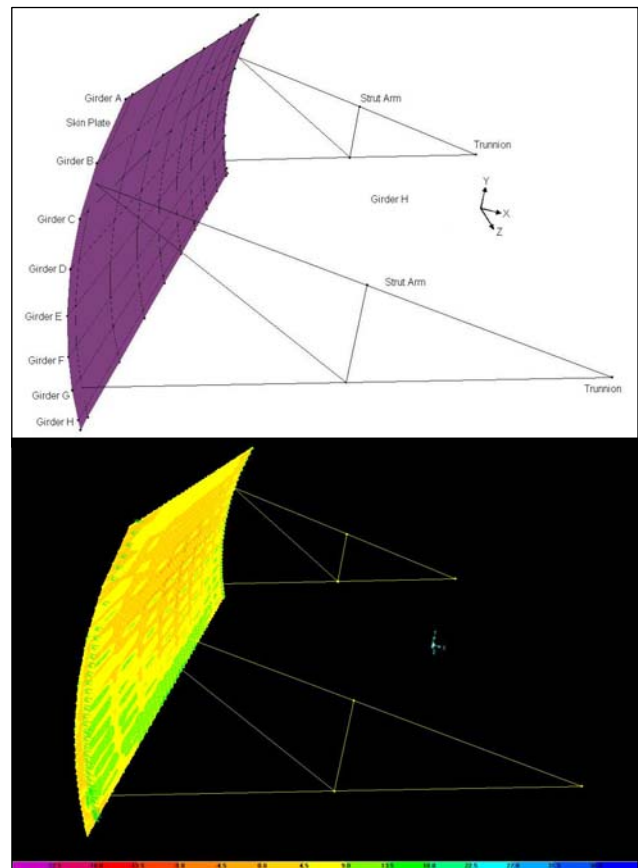
**Figure 14. Tainter gate layout and skin plate shell**

A 3-D model of existing and new tainter gates was created using frame and shell elements of SAP2000. Figure 14 shows the general layout of a gate with the loading diagram. The frame members' demand to capacity ratios (DCRs) were determined from the SAP2000 finite element analysis. It was determined that the Load Combination that included the factored dead, mud, ice, hydrostatic and seismic loads governed. Existing tainter gate trunnions were checked against the allowable bearing pressure of 35 MPa for the unfactored load combination that produces maximum reaction at the trunnion. The calculations showed that the maximum induced bearing pressure at the trunnion is 17 MPa, which is well within the allowable limit of 35 MPa.

The existing gate leaves and operating equipment were analysed to determine if they would be adequate for the raised reservoir elevation. The structural and mechanical components were evaluated against Corps of Engineers requirements. Under the current design, the structural members, skin plate, and hoisting equipment meet the requirements. The existing gates will thus be provided with a 60cm skin plate extension along the top of the tainter gate, with the extension welded onto the outside of the existing skin plate.
