# Extreme Flooding in the Kimberley and the Loss of WA's Fitzroy River Bridge

Krey Price

Surface Water Solutions

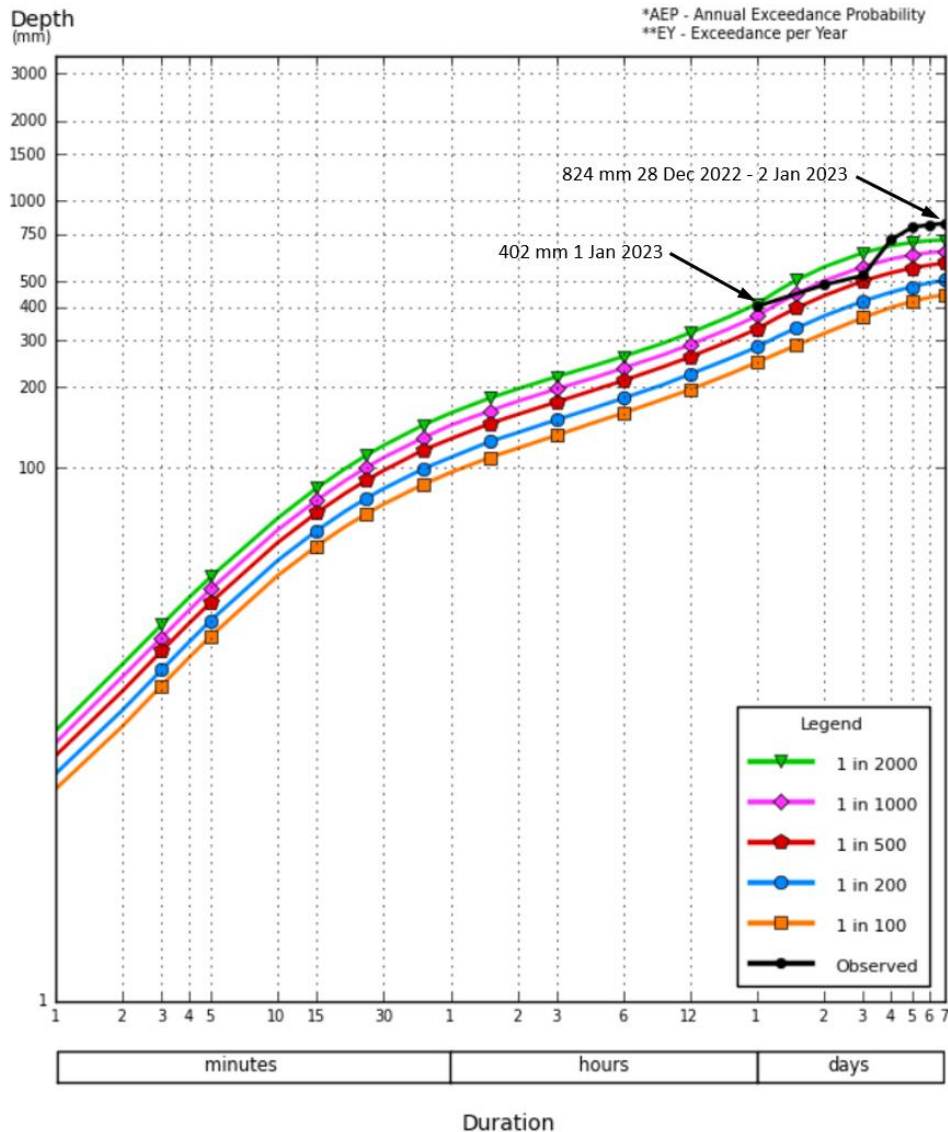
The Dimond Gorge precipitation gauge (Site ID 502139), located approximately 90 km upstream of Fitzroy Crossing, recorded a 24-hour rainfall depth of 402 mm on 1 Jan 2023, and a 1-week total rainfall depth of 824 mm to 2 Jan 2023. Based on Bureau of Meteorology (BoM) Intensity-Frequency-Duration (IFD) data, the 24-hour total corresponded to the 1 in 2,000 Annual Exceedance Probability (AEP) event, and the 4-, 5-, 6-, and 7-day totals substantially exceeded the 1 in 2,000 AEP event (Figure 2). Over a 30-year period of record, all totals from 1 to 7 days more than doubled the previously recorded maximum precipitation depths.

**Figure 2. Dimond Gorge precipitation from 28 Dec 2022 – 2 Jan 2023 against BoM IFD.**

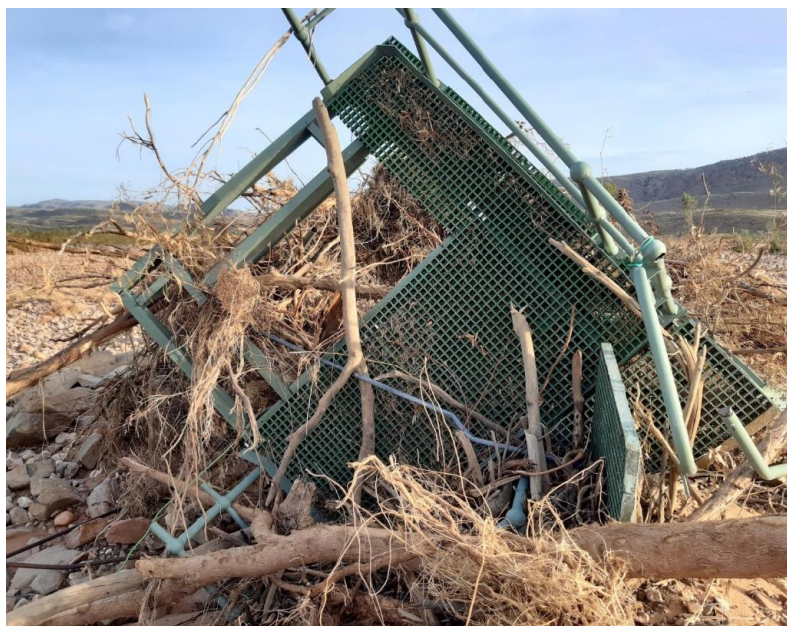
The Dimond Gorge river gauge on the Fitzroy River was destroyed before the peak flood level could be measured; however, calibrated hydraulic modelling using high water marks yielded a peak flow rate of nearly 20,000 m<sup>3</sup>/s for the January 2023 event at Dimond Gorge. The destroyed river gauge is shown in Figure 4. Observed flood levels were 4 m higher than the previous record, and estimated flow rates were almost double the previous maximum peak flow since readings began in 1961.

Figure 4. Destroyed river gauge at Dimond Gorge (Lawry 2023).

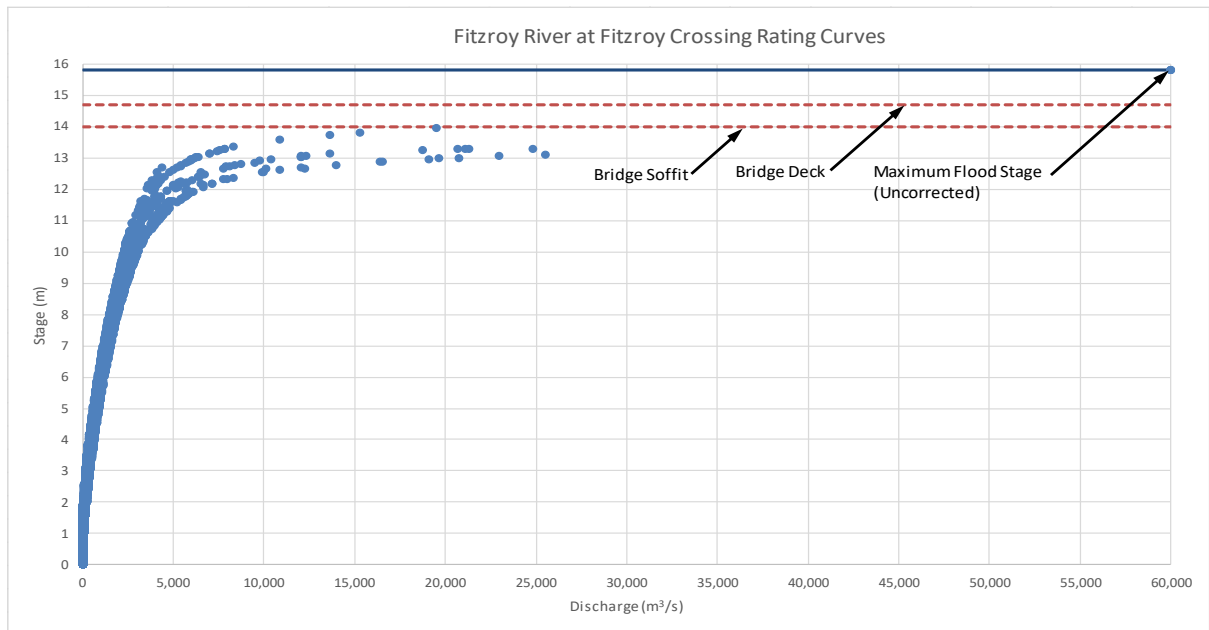
Figure 8 shows all peak daily flood levels and flow rates acquired at Fitzroy Crossing since 1957. As indicated by the plotted points, the rating curves that serve as a basis for converting flood level to discharge have been frequently revised to reflect changing conditions; 18 separate rating curves have been developed by DWER and Main Roads Western Australia (MRWA) since records began (Greening et al. 2019), with a series of adopted curves subsequently consolidated into the current flood records (DWER 2023). As indicated by the points on the rating curve and validated by flow measurements, a single elevation point measured at the Fitzroy Crossing gauge location may reflect a relatively wide range of total flow rates across the floodplain; these results have subsequently been confirmed by 2D hydraulic modelling.

**Figure 8. Fitzroy Crossing rating curve (DWER 2023).**

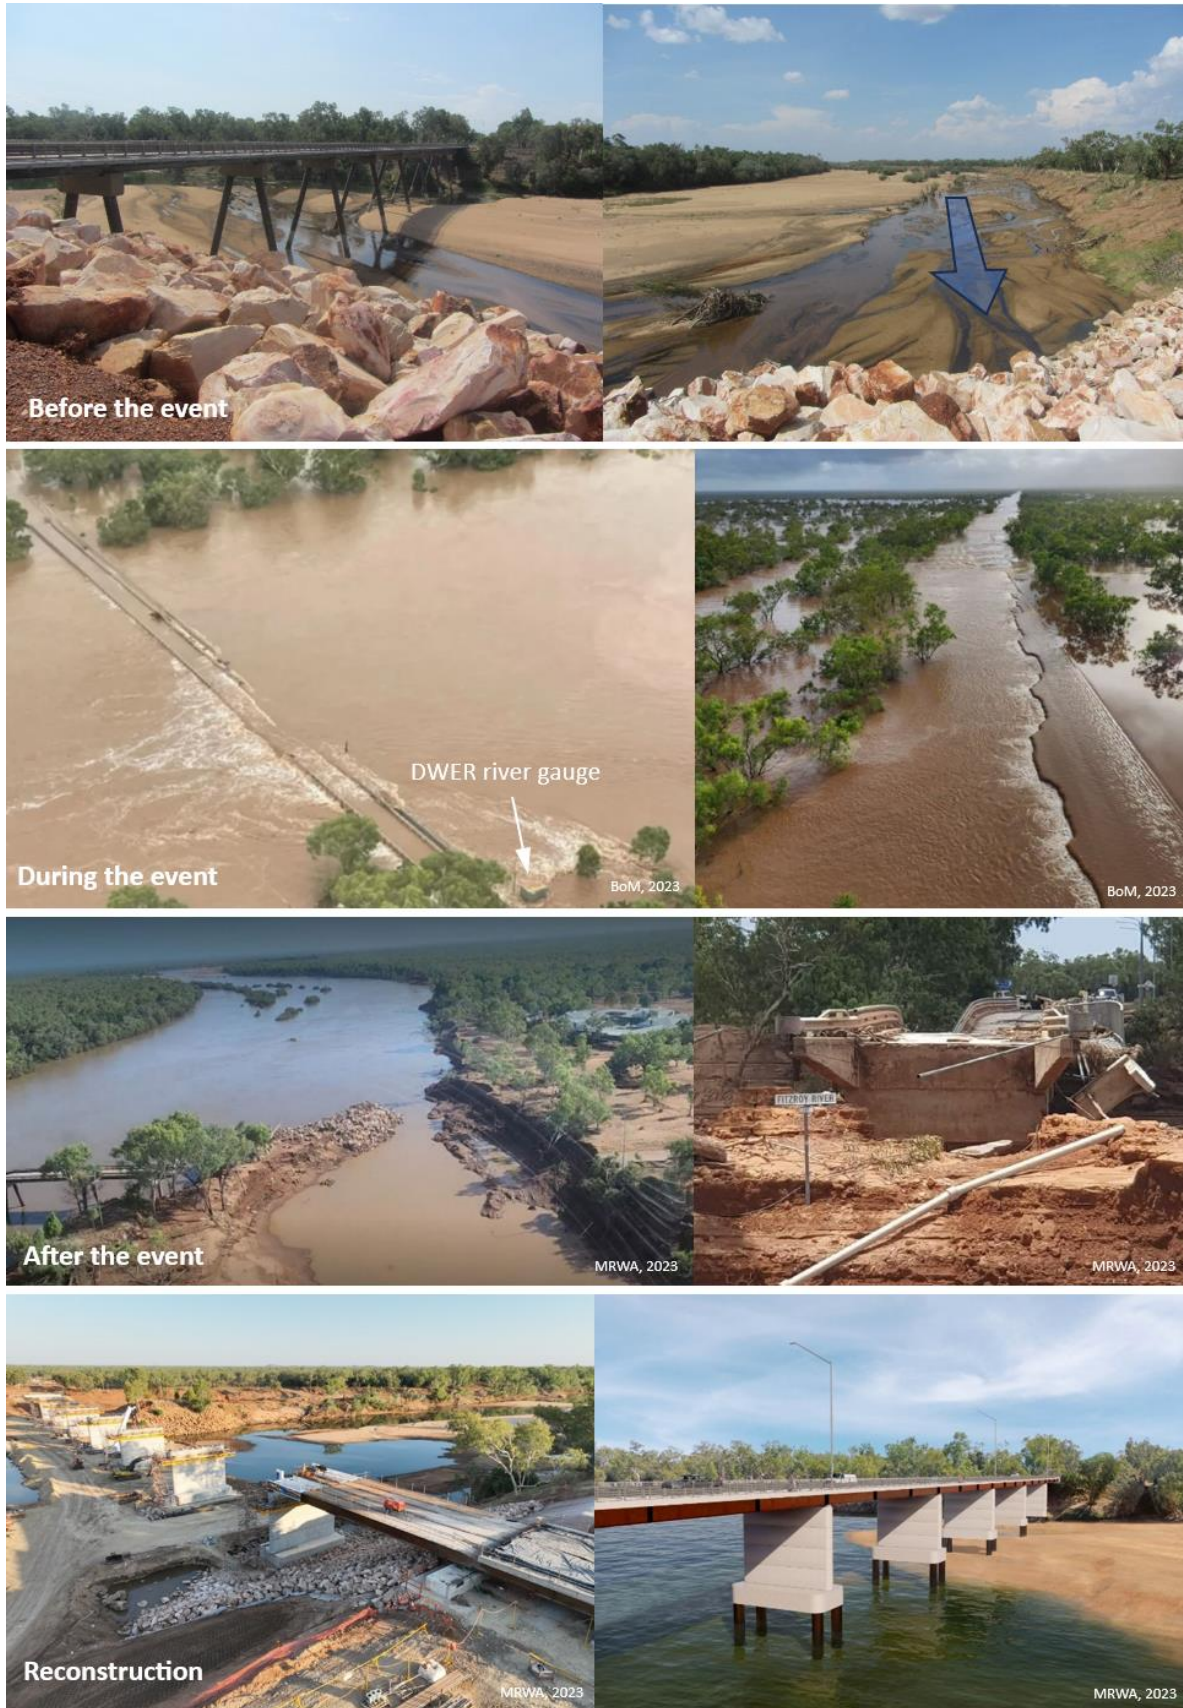
A 270-m span bridge was constructed along the current alignment of the Great Northern Highway in 1974, replacing an original bridge located 3 km upstream that was periodically inundated by floodwaters. The 1974 bridge was designed by the Main Roads Department of WA to accommodate a total flow of 5,100 m<sup>3</sup>/s (DMR 1972) and was constructed by Hercules Construction. The bridge served as the only all-weather roadway corridor connecting the west and east Kimberley. During its nearly 50-year life of operation, the bridge had not been subject to overtopping; however, erosion threatened at times to undermine the eastern bridge abutment. In response to approximately 50 metres of lateral bank erosion between 2002 and 2011, MRWA placed rip rap bank protection along the eastern abutment. Figure 9 shows the bridge structure and armour rock with a directional arrow showing the flow direction toward the revetment that was constructed in 2011.

As shown in Figure 9, the bridge deck was overtopped on 3 January 2023, and floodwater circumvented the armour rock at the eastern abutment. Additional lengths of Great Northern Highway floodways were significantly damaged within the Fitzroy River floodplain, and sewer and power lines were also destroyed. Evacuation efforts were required from various Fitzroy Valley communities, and a temporary barge and low-level floodway solution was implemented following recession of flows.

**Figure 9. Fitzroy Crossing bridge photographs before, during, and after the 2023 event.**

The revetment along the eastern bridge abutment appears to have largely remained in place during the 2023 flood event; however, the extreme flood flow eroded a channel east of the abutment, with a width of approximately 100 m downstream of the crossing (Figure 9 and Figure 10). A depositional sand bar formed where the side channel re-joined the main channel. The replacement bridge will be approximately 100 m longer than the original bridge, accommodating the additional channel width and reducing hydraulic impacts associated with the constriction and redirection of flow.

The Fitzroy Bridge Alliance was formed with Georgiou Group Pty Ltd, BMD Constructions Pty Ltd, and BG&E Pty Ltd to design and construct a replacement bridge in coordination with MRWA and local Traditional Owners. The replacement bridge (Figure 9) was constructed in-situ on a concrete casting bed and incrementally launched across the river from the west bank. The bridge is supported by seven piers, each with four piles sunk to a depth of 40 m, approximately twice the pile depth of the previous bridge (DMR 1972). The piles are topped with concrete-infilled casings and pile caps supporting the bridge. Roadway repairs are nearly complete, and the bridge is scheduled to open in late 2023. The Fitzroy Crossing river gauge and other destroyed gauges are also being rebuilt to be more robust.

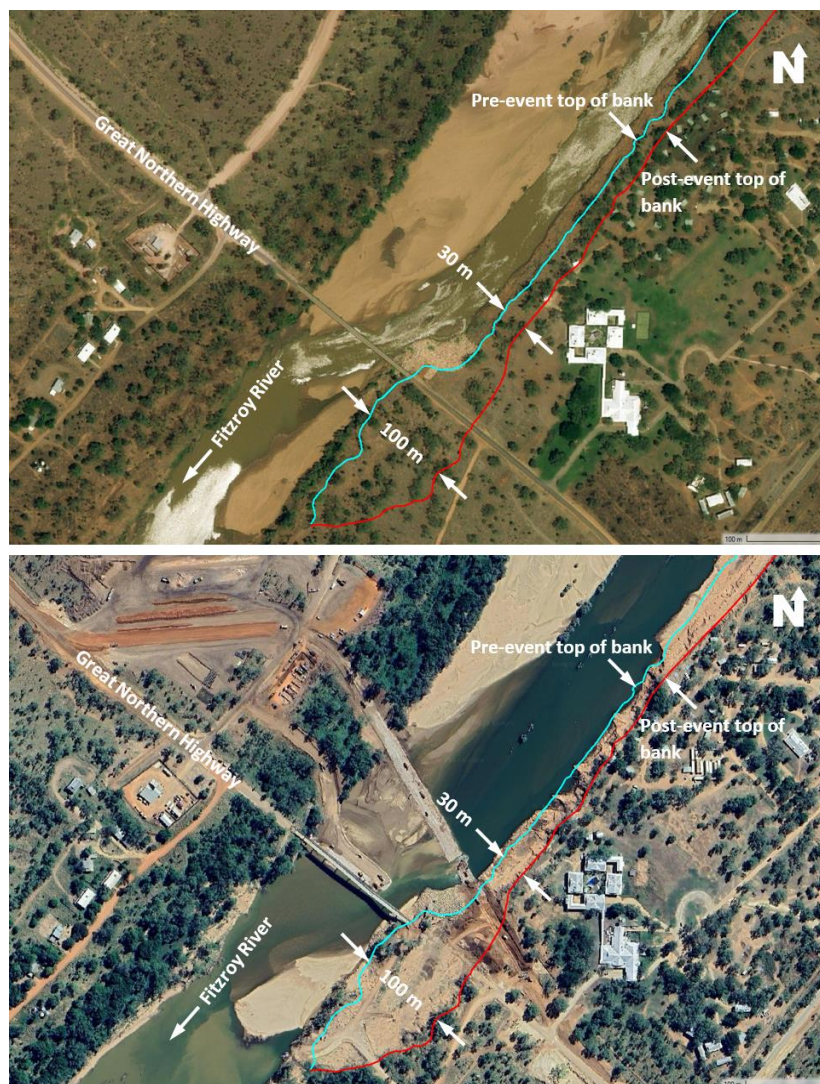
Eight sets of historical aerial photographs of the Fitzroy River were compiled from 2002 to 2023. The results indicate approximately 50 m of lateral bank migration upstream of the Fitzroy River bridge between 2002 and 2022, a recession rate of approximately 2.5 m/year. Approximately 30 m of additional bank recession occurred during the single event in January 2023 (Figure 10).

Similar bank migration rates were observed along the eastern bank of the channel where it coincides with the outside of a major channel bend for approximately 700 m upstream of the Great Northern Highway crossing. No observable bank migration occurred on the inside of the bend (western bank) over the same period of time. Approximately 1500 m upstream of the crossing, the river bends in the opposite direction, and the western bank experienced approximately 10 m of bank migration between 2002 and 2022, and up to 50 m of bank migration during the January 2023 event. The eastern bank of the river on the inside of the bend experienced no significant migration during the same time periods.

**Figure 10. Top of bank migration during the 2023 event.**
