#### Goldsborough Creek

#### Dam Removal and Stream Restoration

**Mason County, Washington**

- Project Sponsored by U.S. Army Corps of Engineers and Washington State Department of Fish and Wildlife
- Design prepared by Tetra Tech, Inc. ISG
- Presented by Krey H. Price, P.E.

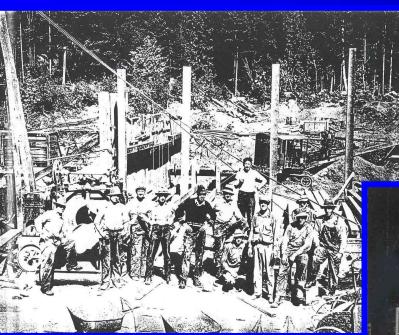
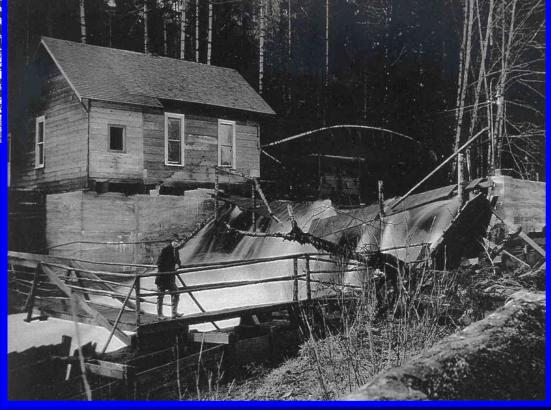
**Dam History**

- Dam Built in 1921
- Modified in 1932

- Abandoned in 1950's
- Stabilized in 1997

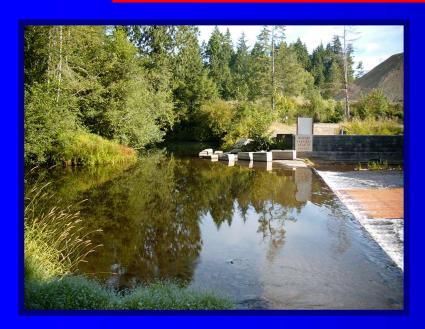
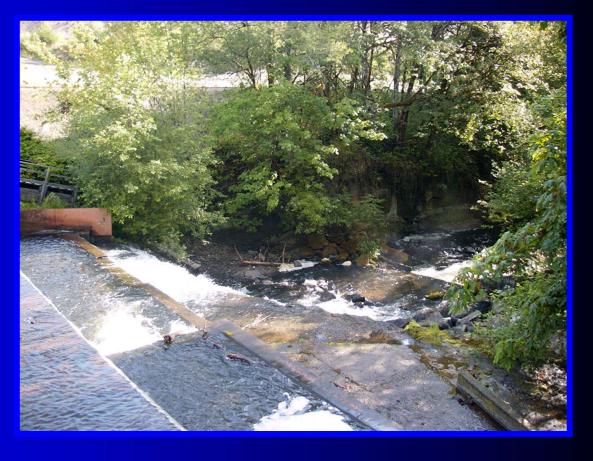
**Existing Dam**

- Upstream Siltation
  - No Storage

Downstream ErosionImpedes Fish Passage

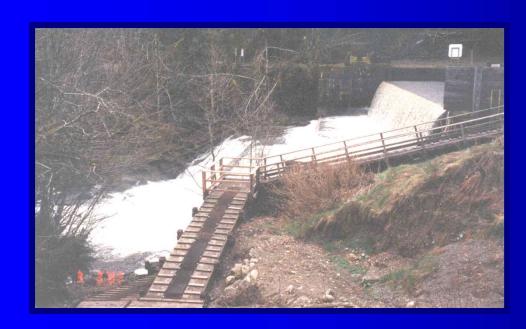
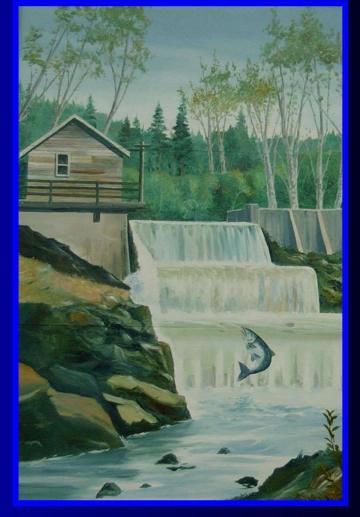
## Design Analysis Fisheries

- Existing fish ladder ineffective for most species
- Target species is Chum Salmon
- Maximum drop height 1 foot

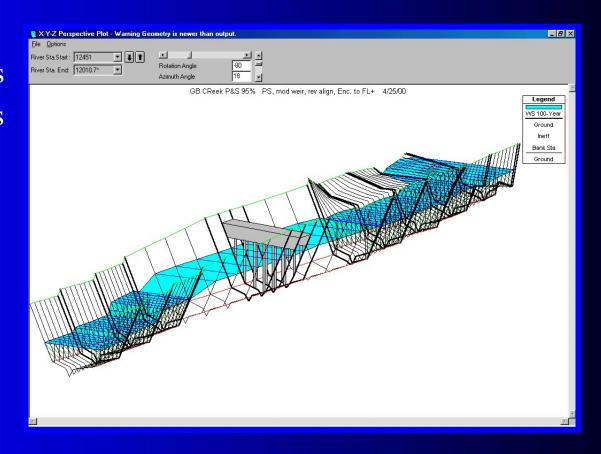
# Design Analysis Hydraulics

- HEC-RAS Analysis
  - Model incorporated various alignments and weir configurations
- Local Analyses
  - Stream banks at weirs
  - Stream invert at weirs

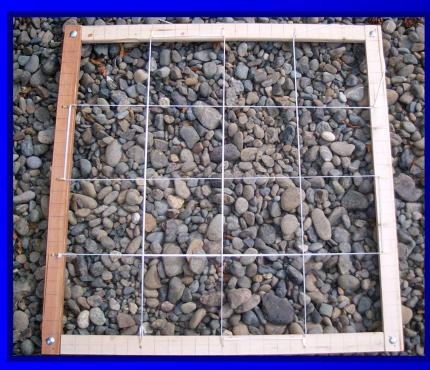
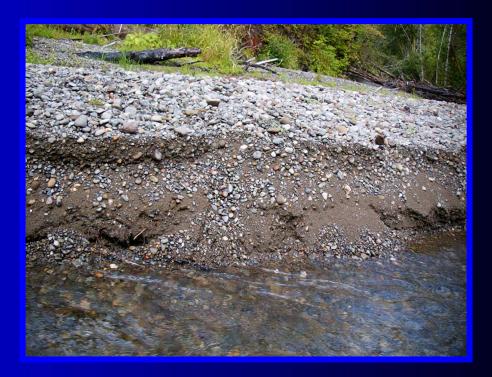
## Design Analysis Sedimentation

- Sieve Analyses
- Pebble Counts

6" Grid Shown

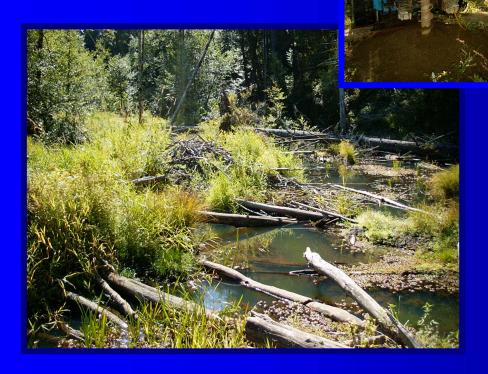
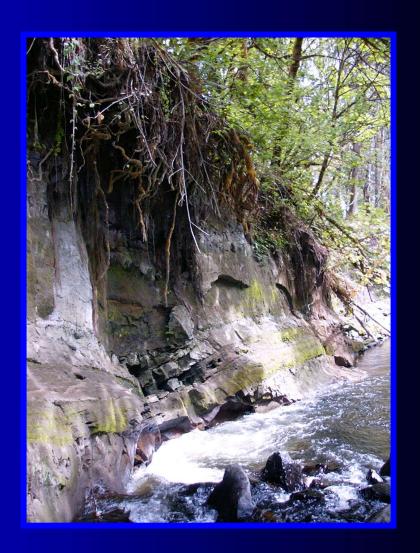
### Design Analysis Geotechnical

Kitsap Formation

Wetlands

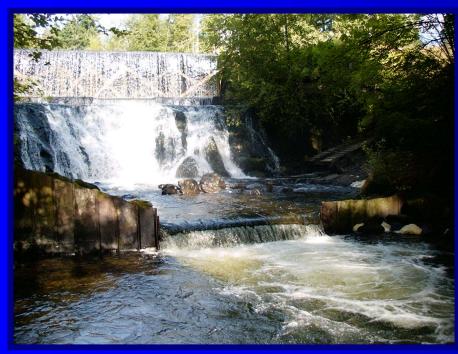
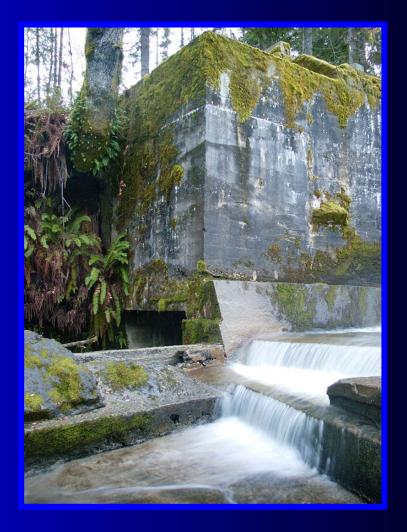
## Design Analysis Demolition

- Timber (Dam and Fish Ladder)
- Sheet Pile
- Concrete
- Unknown Quantities

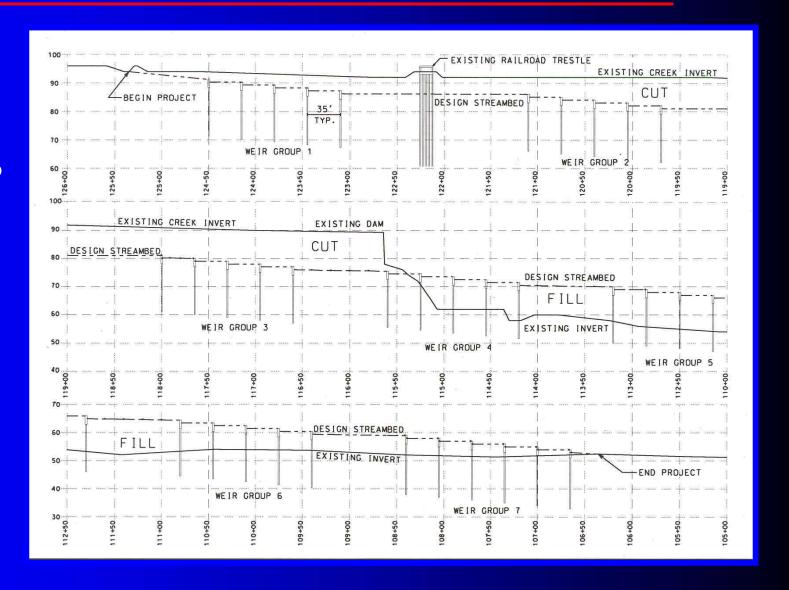
### Stream Restoration General Profile

- 7 Weir Groups
- Cut and fill areas
- Existing S = 0.5%
- Design S = 2.5%

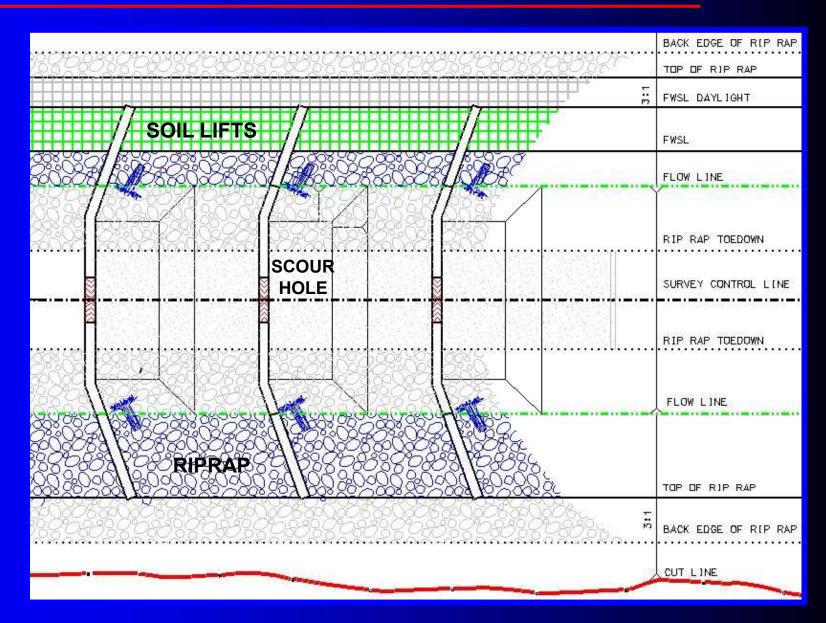
## Stream Restoration Weir Plan

- 20° Dogleg
- Width Varies

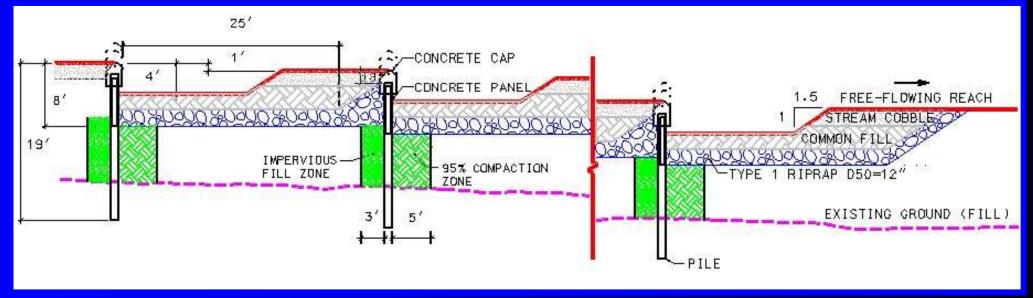
### Stream Restoration Weir Profile

- Preformed Scour Holes:
  - Subsurface riprap
  - Common fill
  - Stream cobble
- Compaction Zones

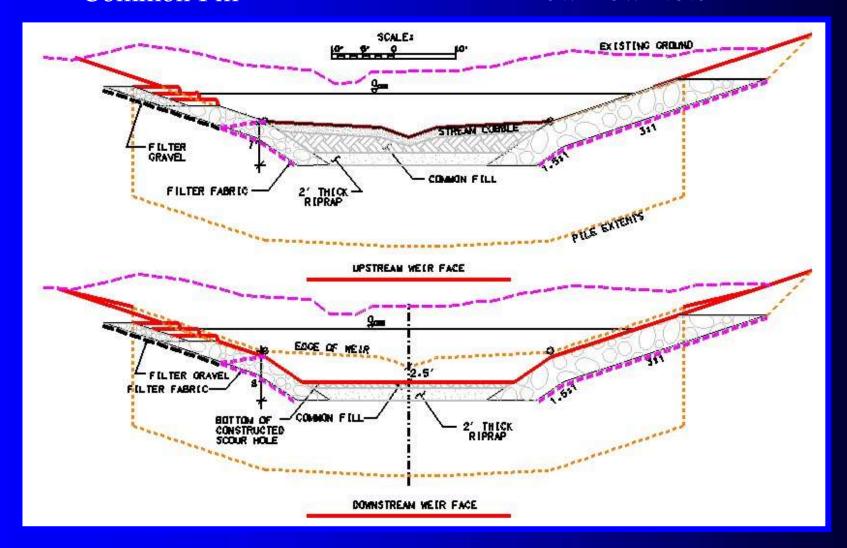
# Stream Restoration Weir Section (cut)

- Channel Invert Protection
- Common Fill

- Stream Cobble Layer
- Low-flow Notch

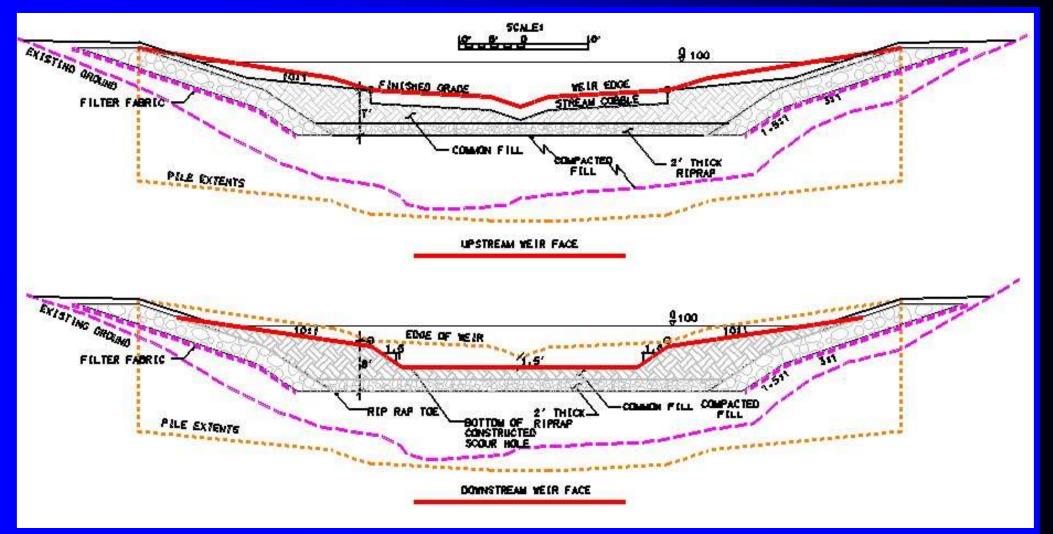
# Stream Restoration Weir Section (fill)

- Channel Invert Protection
- Common Fill

- Stream Cobble Layer
- Low-flow Notch

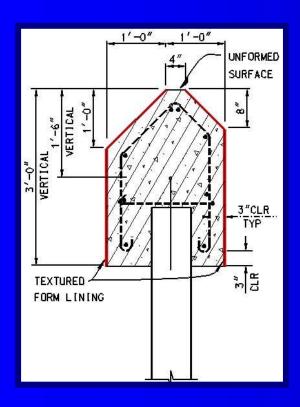
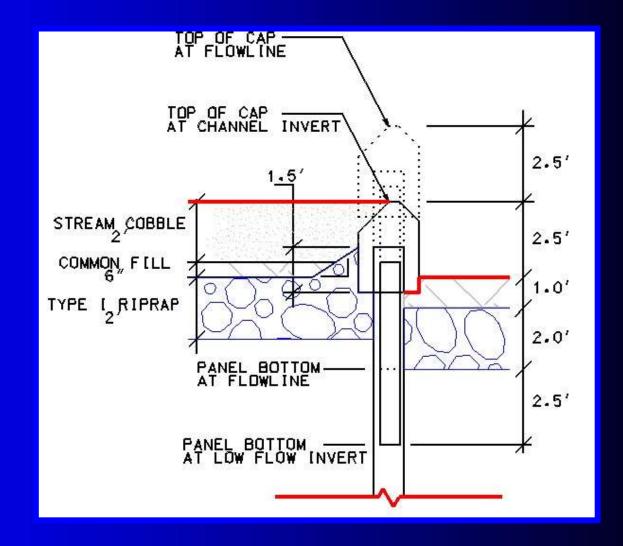
### Stream Restoration Weir Details

#### Weir Cap

- Shape
- Material

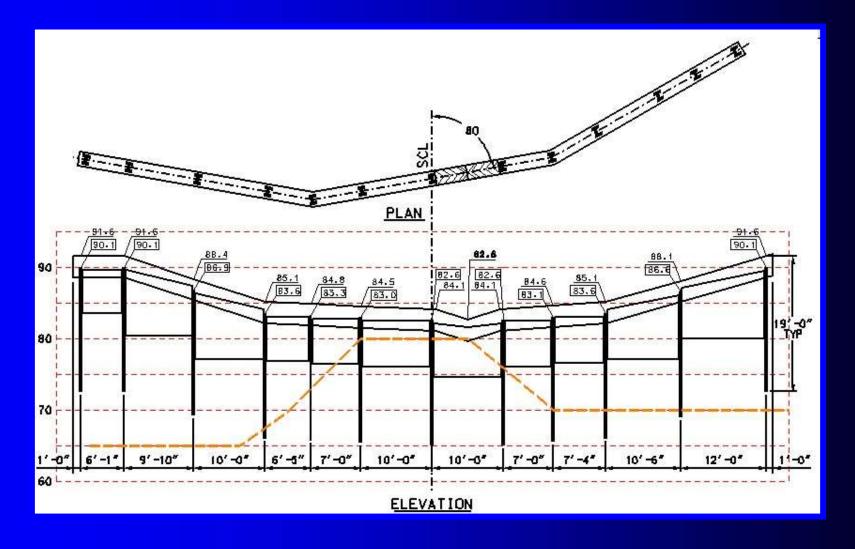
### Stream Restoration Weir Details

H-Pile vs. Sheet Pile

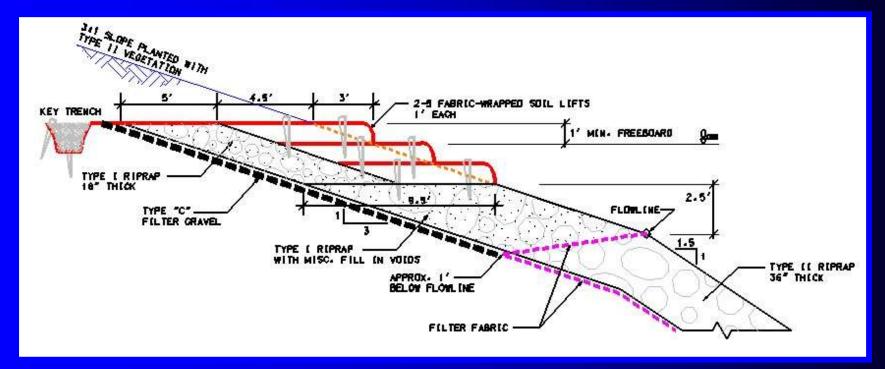
#### Stream Restoration Bank Protection

- Type 1 Riprap 18" layer, D50 = 12"
- Type 2 Riprap -36" layer, D50 = 24"
- Type 3 Riprap -54" layer, D50 = 36"
- Fabric-Wrapped Reinforced Soil Lifts

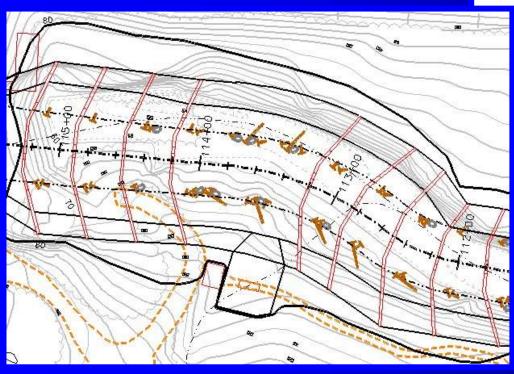
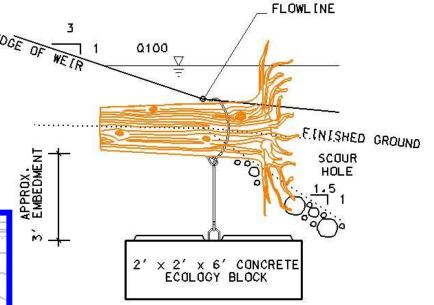
## Stream Restoration Habitat Features

- Large Woody Debris
- Boulders

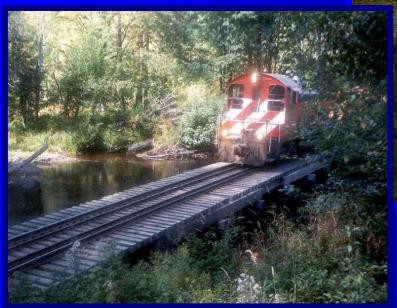
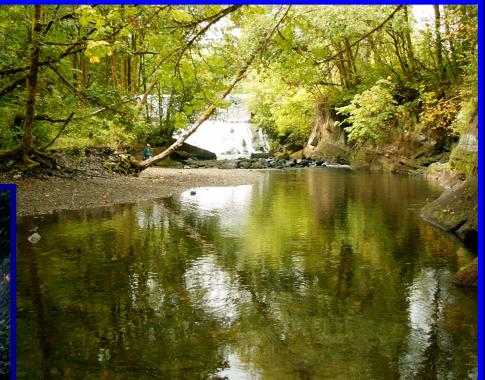
### Stream Restoration Additional Considerations

- Temporary Diversion
- Railroad Trestle
- Downstream Utilities

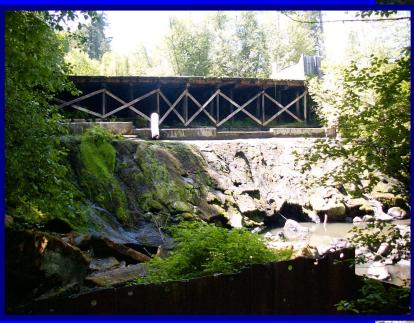
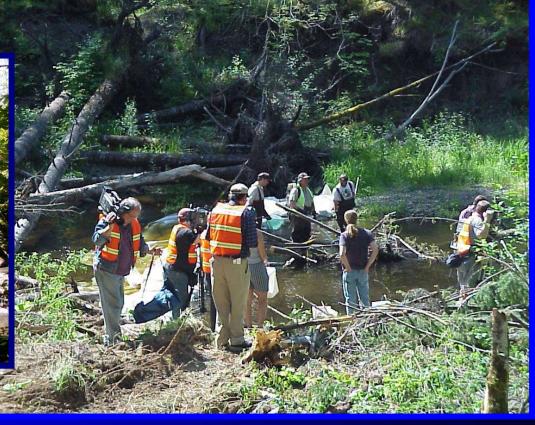
### Construction Summer 2001

- Mobilization
- Stream Diversion / Fish Capture
- Clearing and Grubbing

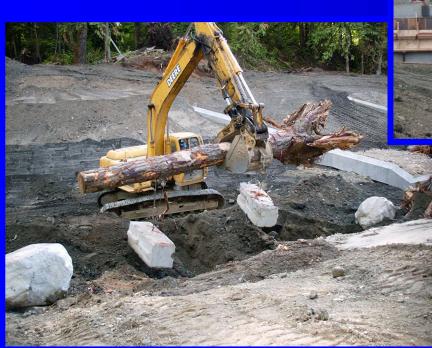
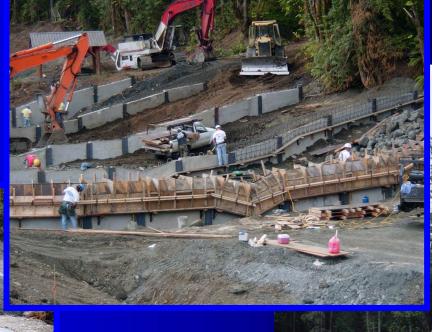
## Construction Misc. Construction Photos

- Pile Driving
- Concrete Forms
- Habitat Features

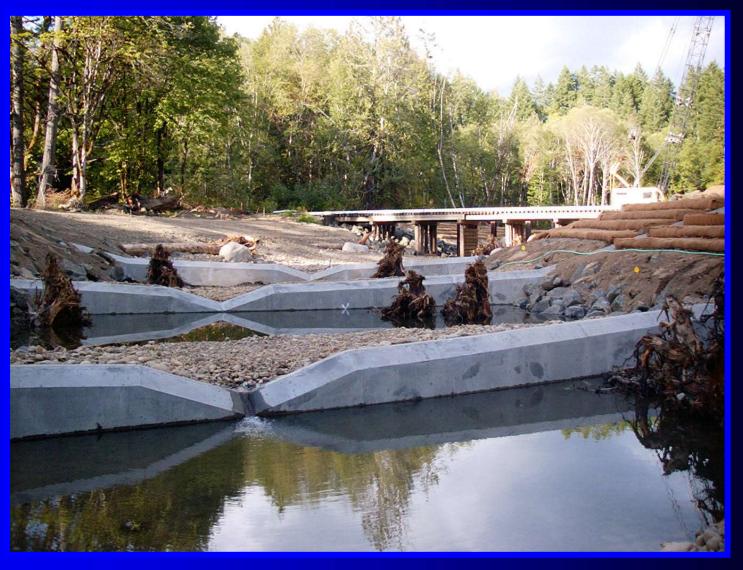
# Construction Final Grading

- Rewatering
- Revegetation
